Church of St Mary

Gissing

Record and Analysis Report into the

Nave and Chancel Roofs

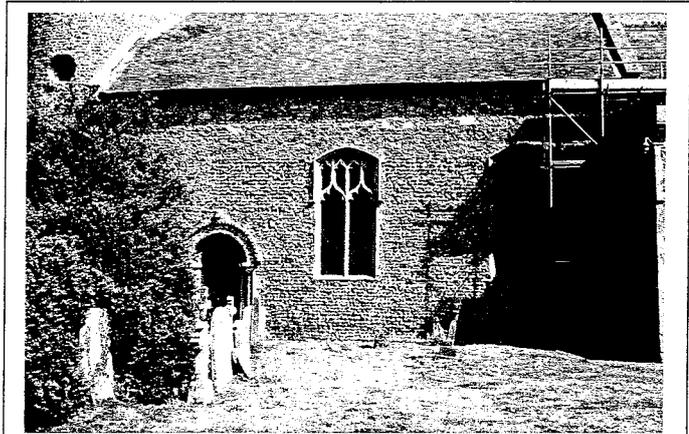
8: Detail of south side of the nave showing rebuilt wall

which the exterior and interior walls were covered was chipped off and a new cement render finish applied, and once the roofs were removed (rather astonishingly this means all of them, even that over the porch) the tops of the walls were repaired and levelled to receive new plates on 9" sleeper walls and were 'beam fill[ed] throughout'. The east and west gables were taken down and rebuilt, the brick tower parapet and stringcourse below it were removed and rebuilt in flint, and four 'air drains' were provided round the church below the new floor level and fitted with 'No. 4 air gratings in same'. All the jambs and arches of the windows were taken out and replaced, and the 'modern clerestory' windows to the south side of the nave (shown in Ladbroke's 1823 drawing) were removed and the holes filled in. The north side of the chancel apparently had a gaping hole in it, so this was fixed and a brick plinth course which then existed under the east wall was taken out and renewed in flint once the underpinning had been done. The tower arch had been at least partially blocked for the west gallery, and this was opened up when the gallery was scrapped, and the font was apparently not even secured to the floor.

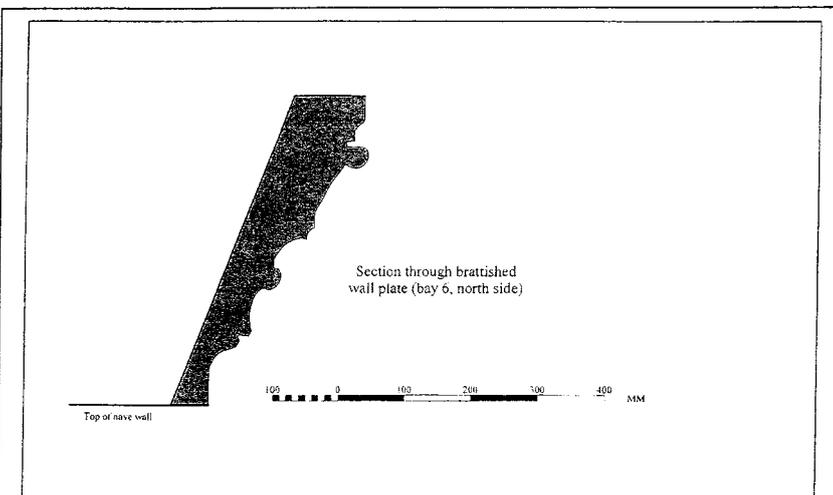
15: Section through wall plate, north side, bay No. 6

The tall brattished wall plate splays inwards from the plane of the nave walls and takes the form of a narrow wedge of carved oak, not of a solid rectangular baulk of timber, so that in most bays it has begun to bow and provides a rather narrow platform for the ashlar struts which rise from it and are tenoned into it with plain mortised joints²³. These ashlar struts are themselves of some interest, as most have thin sheets of wood nailed to their inner surfaces (that is, facing

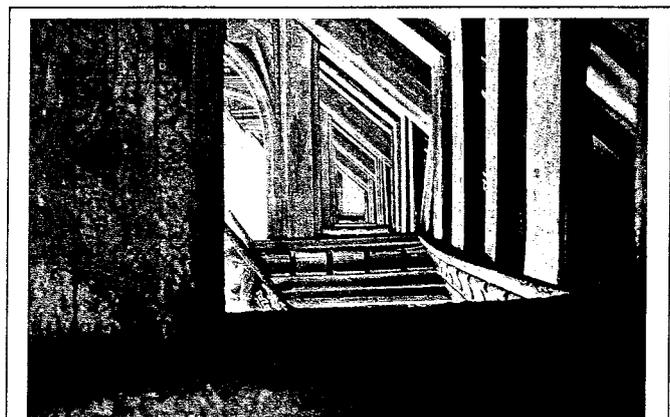
16: View looking west between ashlaring and hammerposts, north side

into the nave) in 1876-77 so that they appear all of the 19th century. In fact the roof was originally provided with vertical boarding covering the ashlaring, and this was trenched into the principal and secondary rafters. The

trenches remain visible in the 15th century rafters and almost all of the original ashlar posts were dealt with by Grimwood by the expedient of sawing off the boards flush with the ashlar posts and attaching thin sheets of wood over the remaining pieces. Most of the ashlar posts therefore consist of three layers like a laminate ply: to the outside the 15th century posts, which are surprisingly narrow, then the 1 cm. thick oak boarding and finally Grimwood's facing sheets.

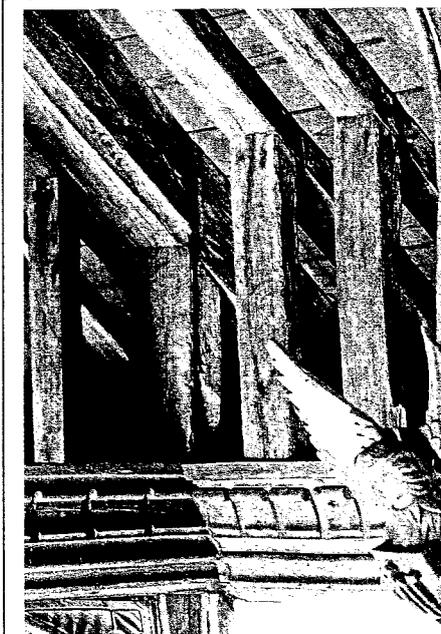
18: Boarding trench in truss No. 3, north side

Boarding of ashlaring was fairly common in the middle ages, being rather elaborate at Knapton church nave in Norfolk, but the drawback was the lack of ventilation at the base of the rafters and consequent rot, so this is almost certainly the reason why the feature was abolished.

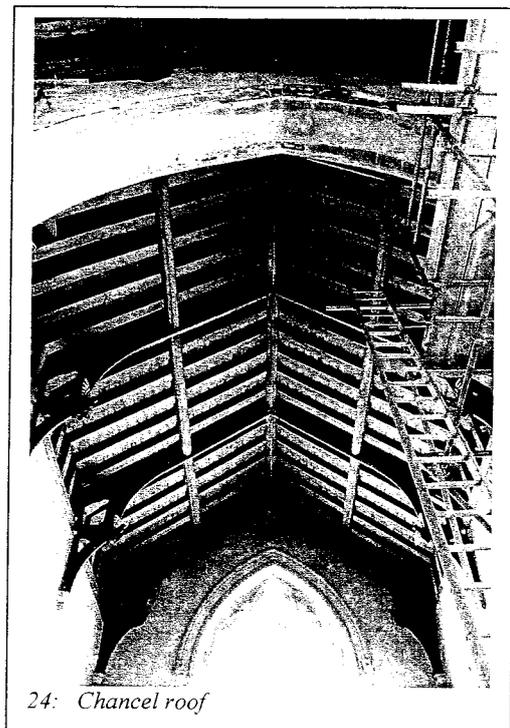
24: *Chancel roof*

The chancel roof is of English oak in four principal trusses forming three bays, and is a false hammerbeam type of the most obvious character, in that the four short plain hammerposts carried on arched braces on wall posts have no structural purpose. They terminate in angels playing musical instruments, and from the posts are flat arched braces to the principal rafters. Ashlar posts, one tier of butt purlins and a ridge piece. The boarding is of Baltic pitch pine. The only description of the roof that we have is contained in Phipson's own specification which explains that in the same manner as the nave roof it was to be entirely removed and thoroughly renovated and new wood provided where necessary. The carpenters were to: 'Restore and refix present angels at ends of Hammer beams and carve and fix new any deficient'. They must all have been deficient, just as all the remaining timbers must have been, because we are left with a very thin imitation of a hammerbeam roof that any medieval master

carpenter would have laughed at, and is all of 1876-7 and has little architectural value. It may be that in taking down both the nave and the chancel gable walls and providing a new east window it was far easier to refashion a new roof to fit with the restoration works, than make the new walls fit a restored 15th century roof. Phipson drew a section of the roof he found in 1876, and this is the same as the roof we now see, leaving just one solution: that the roof he restored was a post-Reformation replacement from some major campaign that has gone unrecorded.
